Bank Stabilization

Cavan Creek

When banks erode, the sediment is washed into the creek where it can damage critical fish habitat and alter water quality. A live cribwall was installed on a stretch of Cavan Creek to prevent further erosion and stabilize the bank.

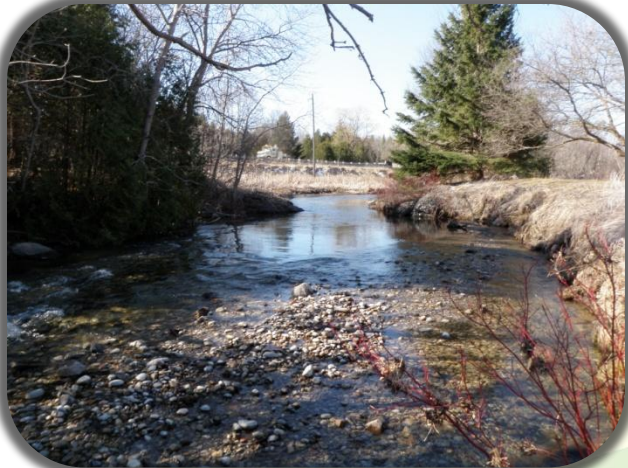
A landowner on Cavan Creek contacted us with concern about severe bank erosion along the creek on his property.

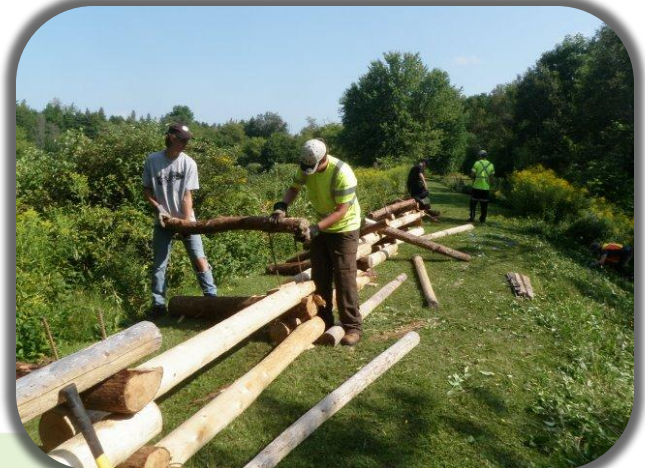
Sediment input from eroding banks negatively impacts fish habitat and water quality. We used a *live cribwall* to stabilize the banks. The process began with building the log cribs.

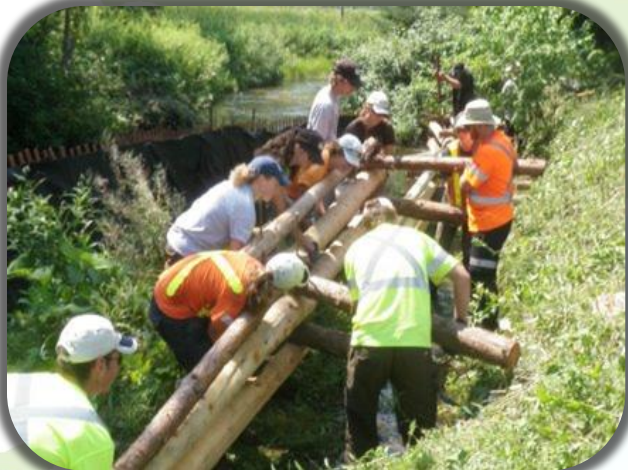
We had lots of help to secure the log cribs into the creek bank.

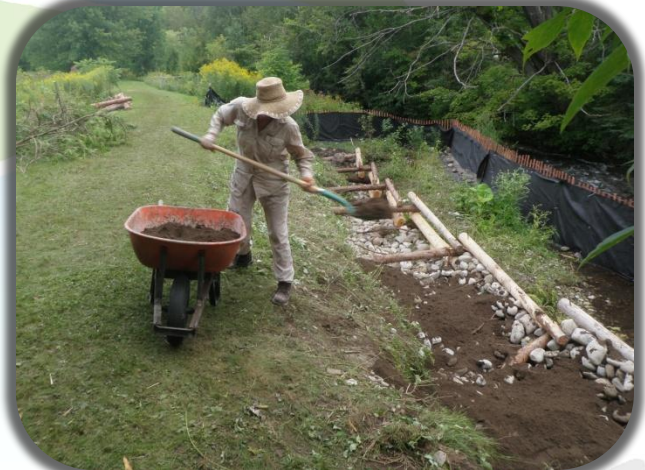
The log cribs were filled with layers of brush, large stones and soil.

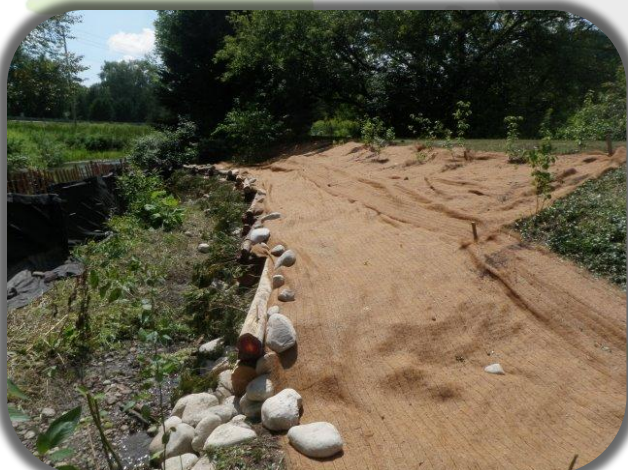
The filled cribs were covered with coir erosion control blanket. Grass seed was spread over the erosion control blanket and shrubs were planted along the top of the bank.

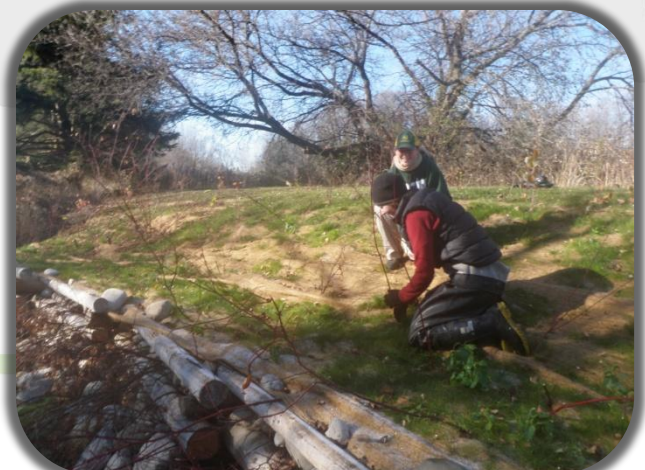
In the fall, we also planted live stakes of dogwood and willow. These stakes will grow to shrubs and create root masses that will help stabilize the bank.
