Bank Stabilization

Black River

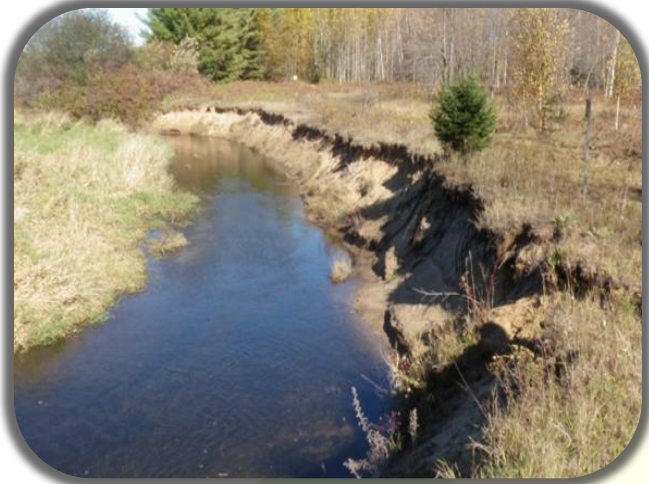
A concerned landowner contacted us about his Black River property; the combination of a bend in the river and a steep bank comprised primarily of sand and loam made this bank susceptible to heavy erosion.

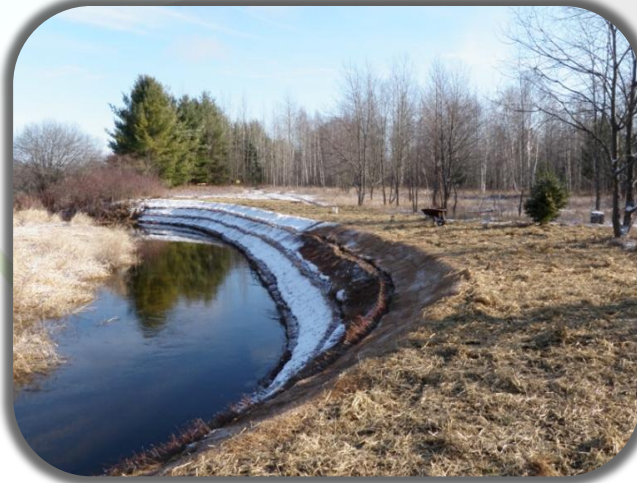
The more gently sloping bank, along with the establishment of bank vegetation and root systems, makes this bank much more stable and less susceptible to erosion.
